Authenticity and the Perceptions of Significance

Examining Rust-en-Vrede in Durbanville, South Africa

A Mini-Dissertation (60-credit research project, course: APG5071S)
submitted in partial fulfilment for the degree of
M. Phil. in Conservation of the Built Environment

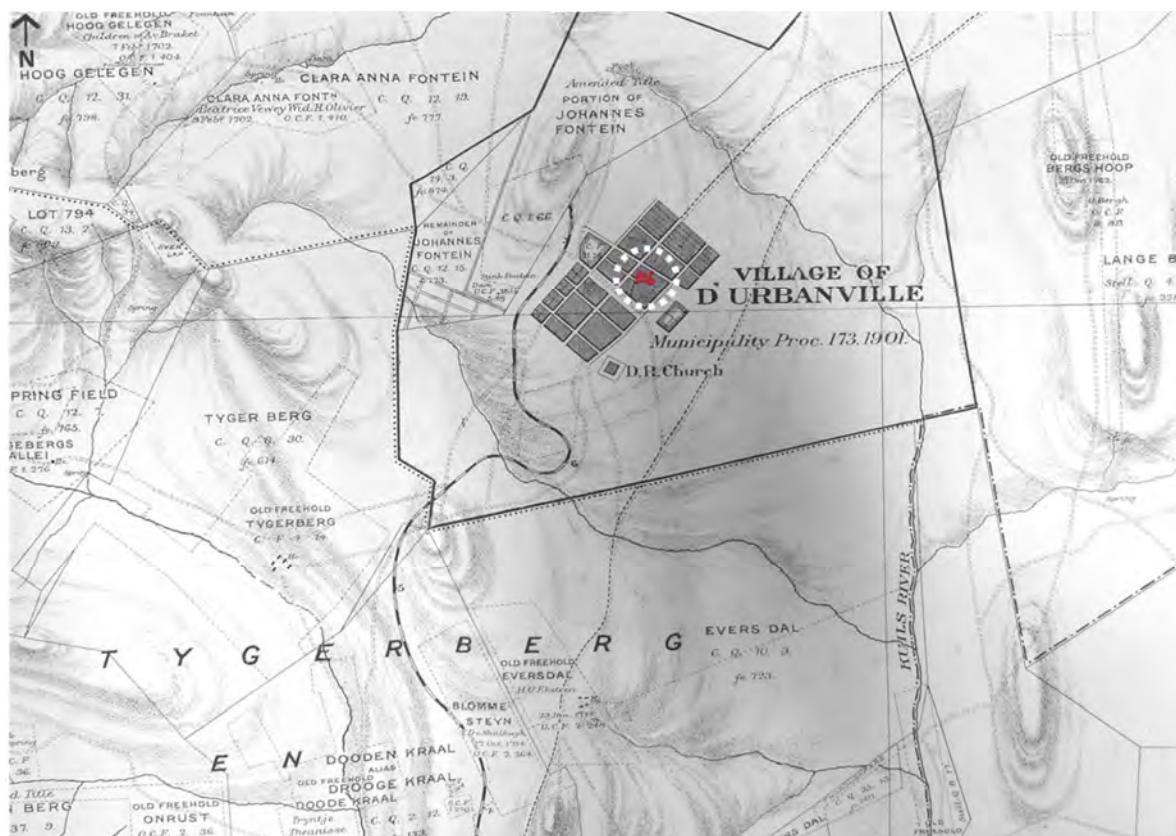
Figure 2: An extract of a map (1931)¹⁵⁵ showing the farms including the original grant extents. Note that the farms surrounding Durbanville do not encroach on the original outspan. The farm Johannes Fontein is located very close to the Pampoenekraal outspan in comparison to all the adjacent farms. The Field Cornet (and miller) Jan Uys received a large parcel of land in 1812 (30,8 hectares) to add to his small plot, resulting in the farm Johannesfontein. Today, this area is Onze Molen and Aurora. (Source: CA ref. M4/1492.)

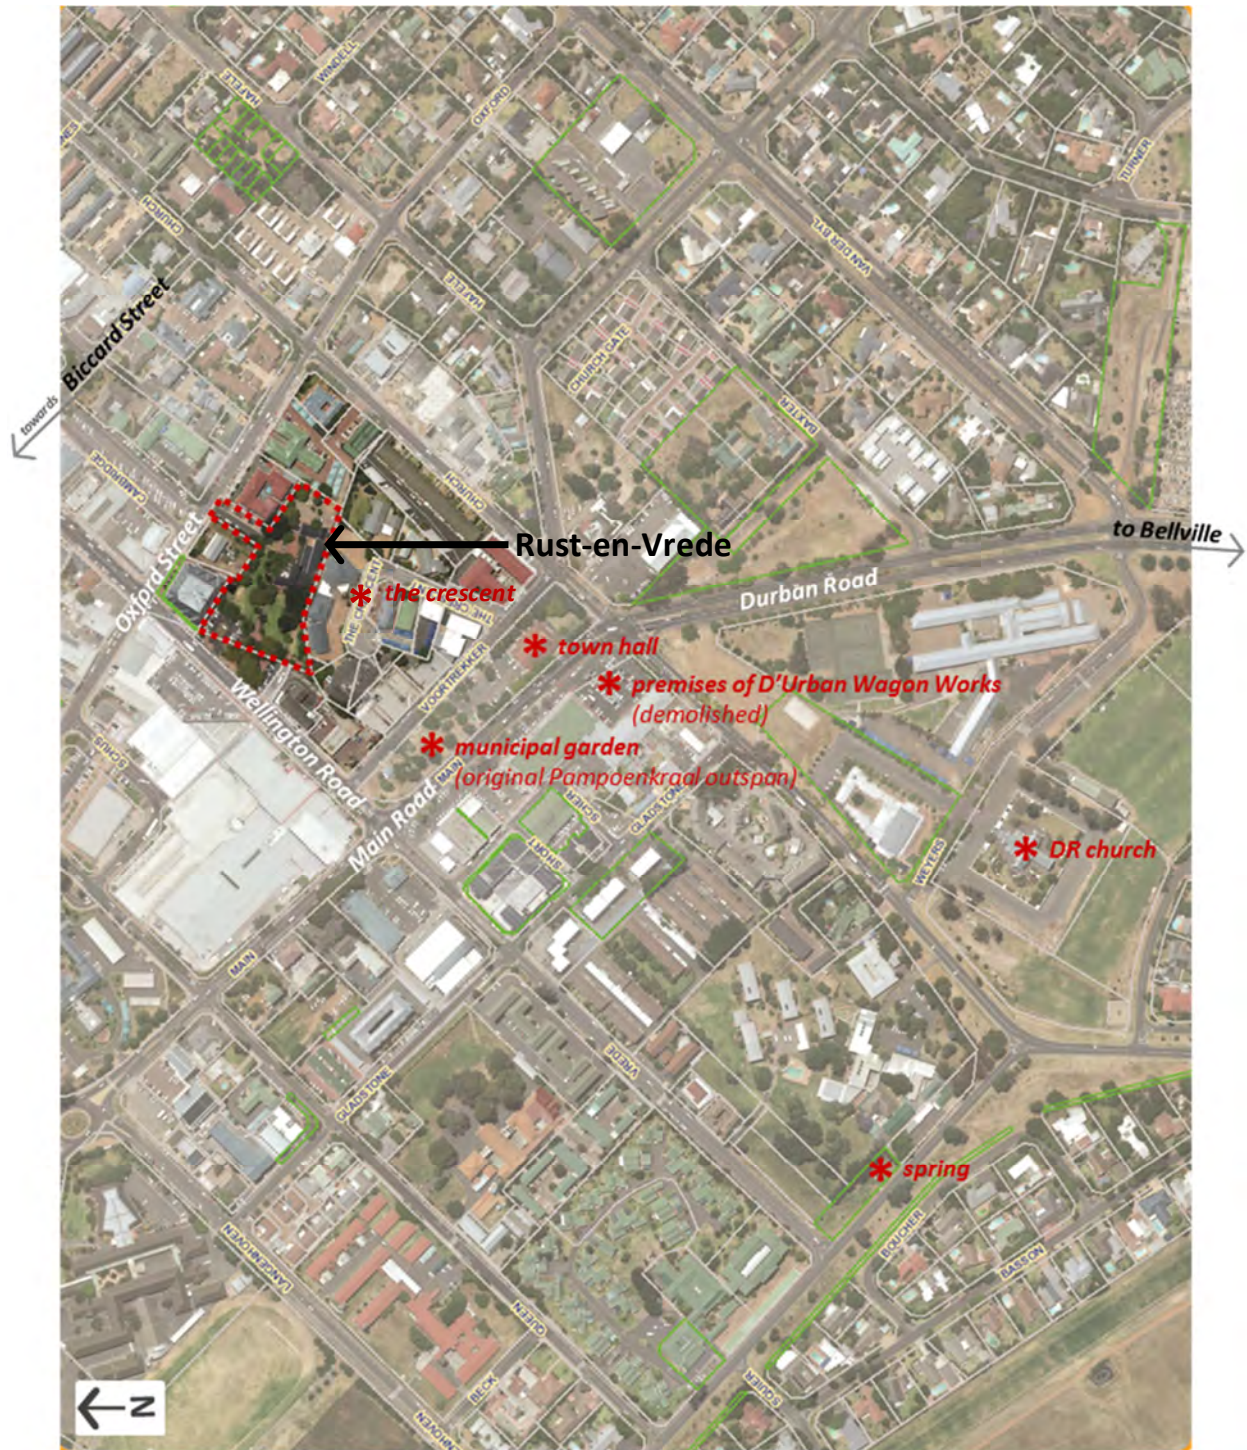
Figure 3: Aerial photograph of a portion of Durbanville. The locations of the Rust-en-Vrede site, the spring, the outspan, the Dutch Reformed Church, D'Urban Wagon Works and the town hall have been indicated. (The locations of the outspan and D'Urban Wagon Works were obtained from Simon van der Stel, 1977.)¹⁶³ (Source: [Online]. Available: <http://maps.capetown.gov.za/isisiv/> [14 January 2014].)

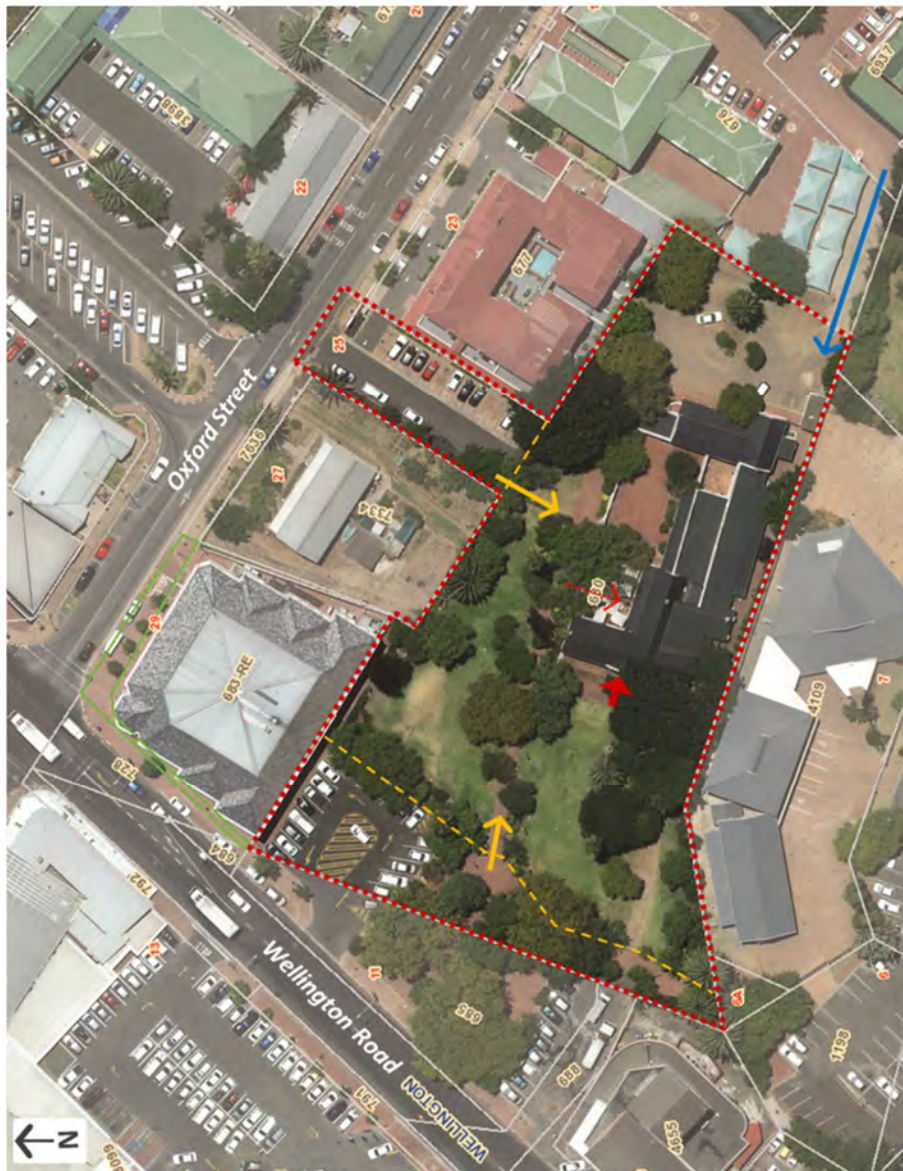
Figure 4: Aerial photograph of Erf 680. The pedestrian access to the building has been indicated with yellow arrows, from Wellington Road and Oxford Street. The yellow dotted lines indicate the location of the security fences which are not located on the perimeter of the property. The only vehicular access to the property is from the east, through the adjacent property (see blue arrow). The large red arrow indicates the entrance to the building complex. However, the red dotted arrow indicates the current access route through the courtyard (changed due to security reasons). (Source: [Online]. Available: <http://maps.capetown.gov.za/isisiv/> [14 January 2014].)

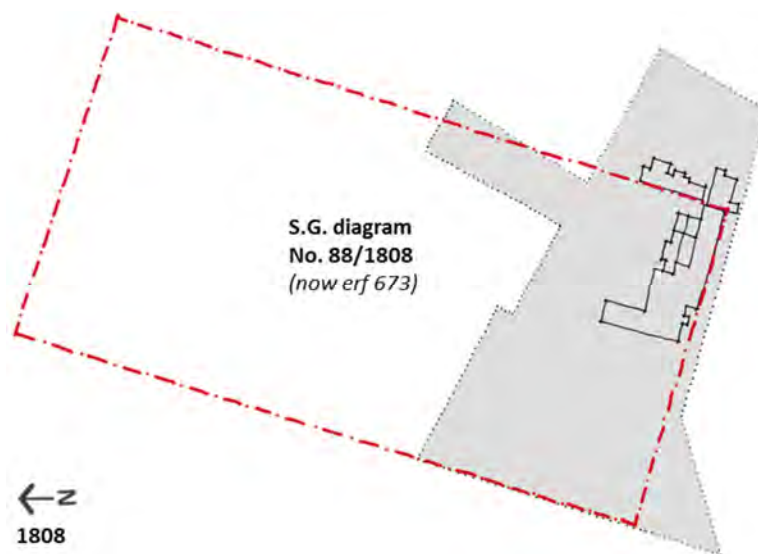
Figure 5: A diagram illustrating the extents of the 1 morgen and 525 square roods of land granted to Schabort, in relation to the extents of the current Erf 680 (dotted) with the Rust-en-Vrede building footprint. The location of the east boundary of the land granted to Schabort has been reflected on the Surveyor General's diagrams of both Erven 680 and 675. This suggests that only a portion of the building footprint (as reflected on C.Q.34.20 of 1881) could have been built by Schabort or De Necker. (Diagram by J. de Waal.)

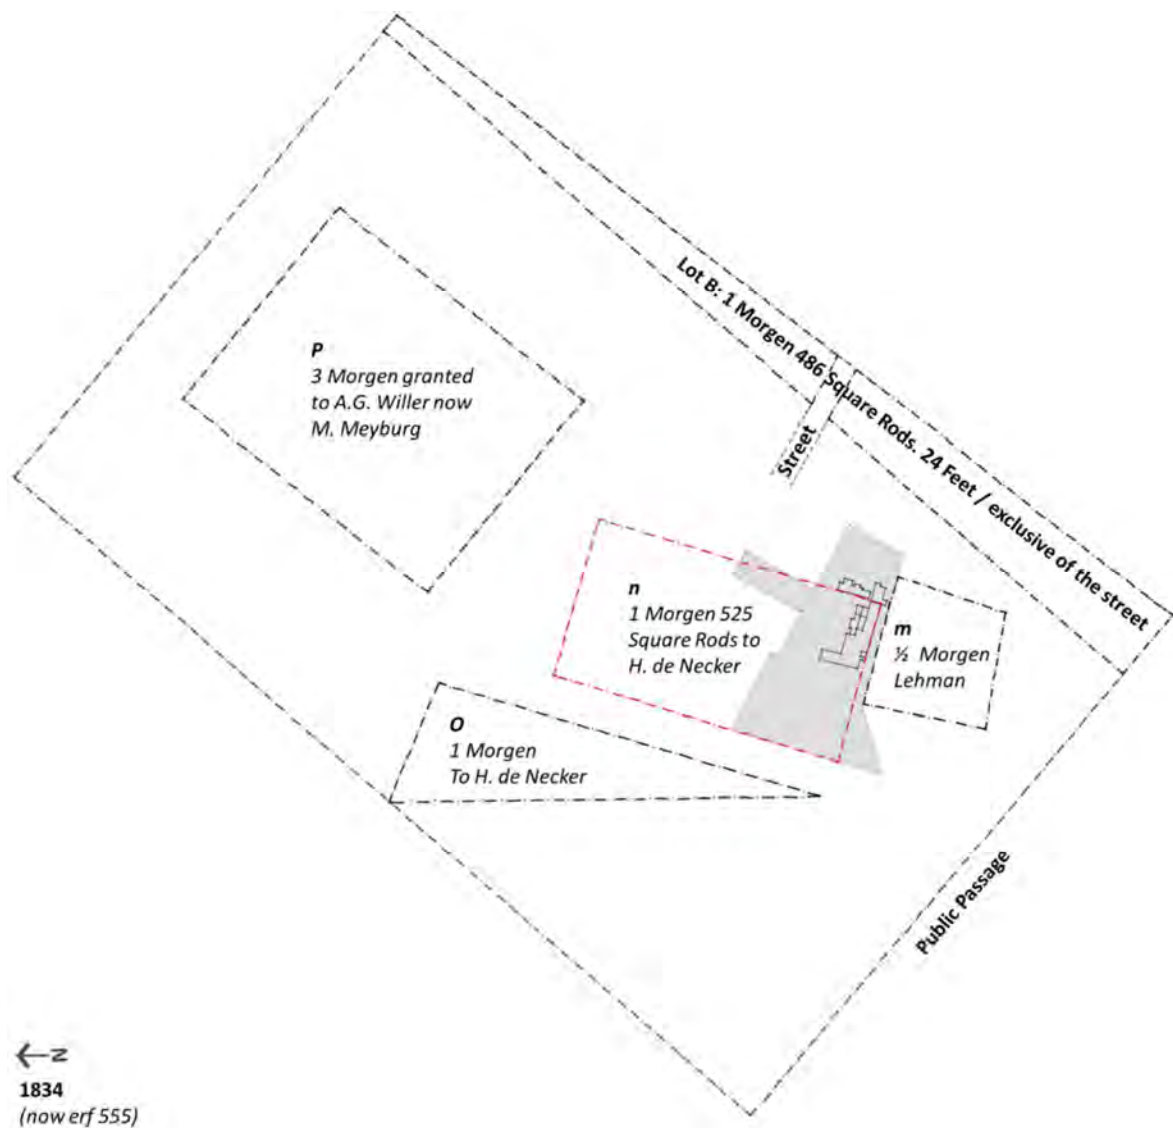
Figure 6: The diagram illustrates the extents of one of the two pieces of land that the government granted to the Church in 1934. (See Annexures 4 and 5 which illustrates both pieces of land.) The five pieces of land, now within the boundaries of the land granted to the Church, were granted previously to private individuals such as Schabort and De Necker. (The two pieces of land have been recorded as Erf 555 by the Surveyor-General.) (Diagram by J. de Waal.)

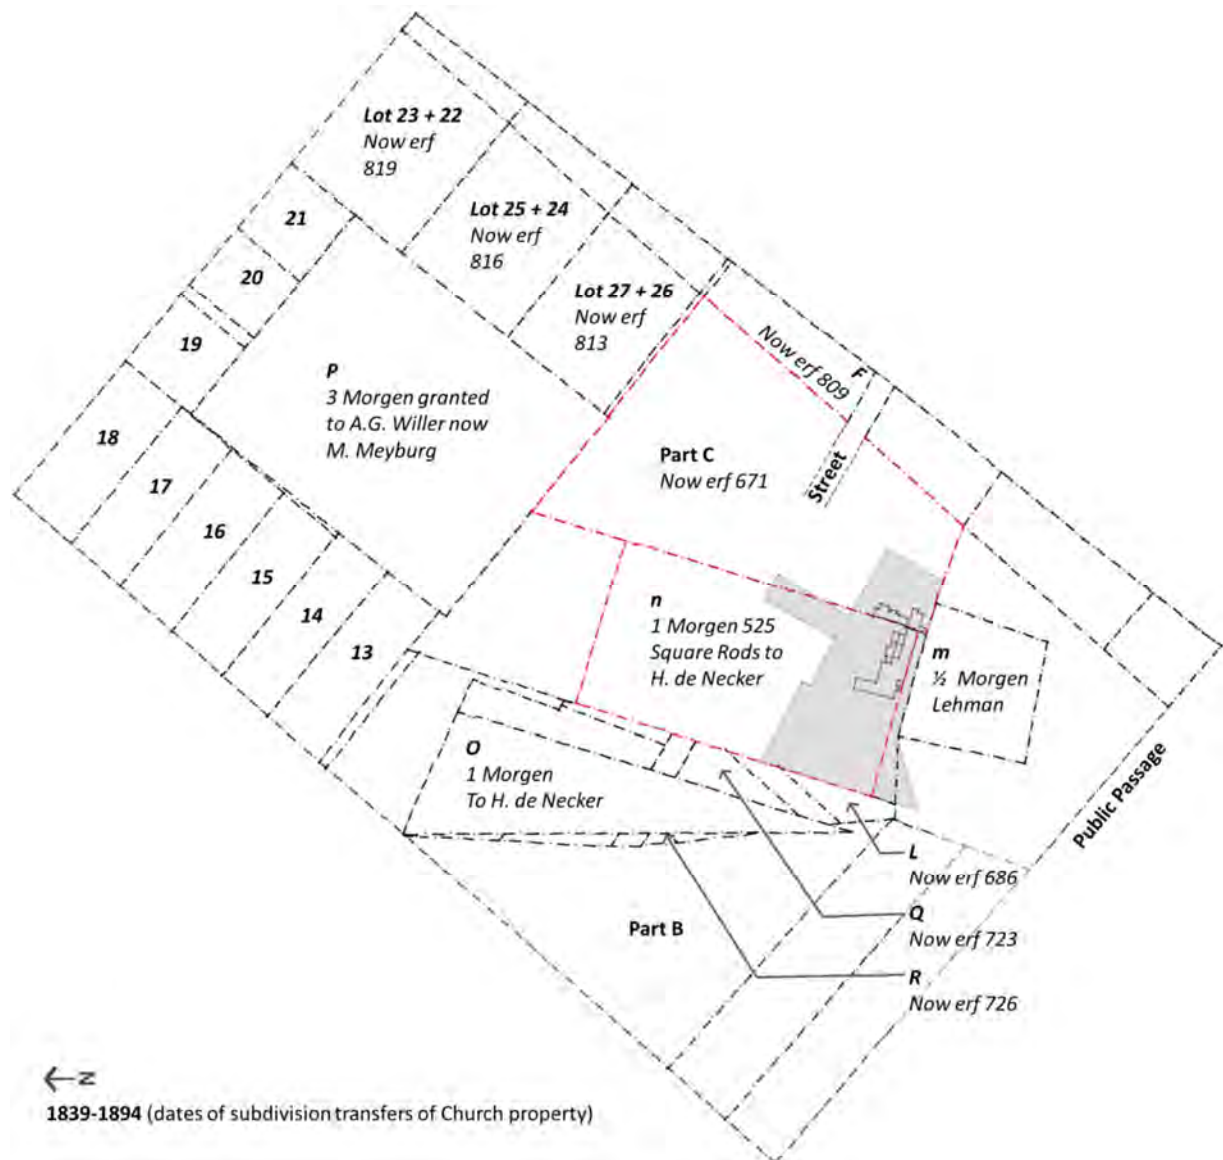
Figure 7: As noted above, the Church auctioned off the two grants in eleven parts in 1836. The diagram illustrates the larger of the two parcels of land with its subsequent subdivisions. Note that there were no subdivisions on Schabart's original quitrent. It also alludes to the establishment of a town with a grid morphology. The extent of the original quitrent is at an angle and therefore explains the unusual geometry of the existing building structures which do not line up with the current street grid. The narrow piece of land located between Parts n and m were included in Erf 675 (see Annexure 5 for note indicating that this property was to be included in C.Q. 34.20). It is not clear why the angle of the splayed portion does not correlate with the exiting erf diagram. Note that Biccard bought Part B and C of this portion of Erf 555 and Part E from the adjacent portion of Erf 555. The King Brothers bought Lots 26 and 27 and Lot KG. James King bought Lots 15 to 18 and Gordon Stewart King bought Erf 723. Petrus Johannes Schabart bought Erf 726. Francis Porter bought Erf 686. (Diagram by J. de Waal.)

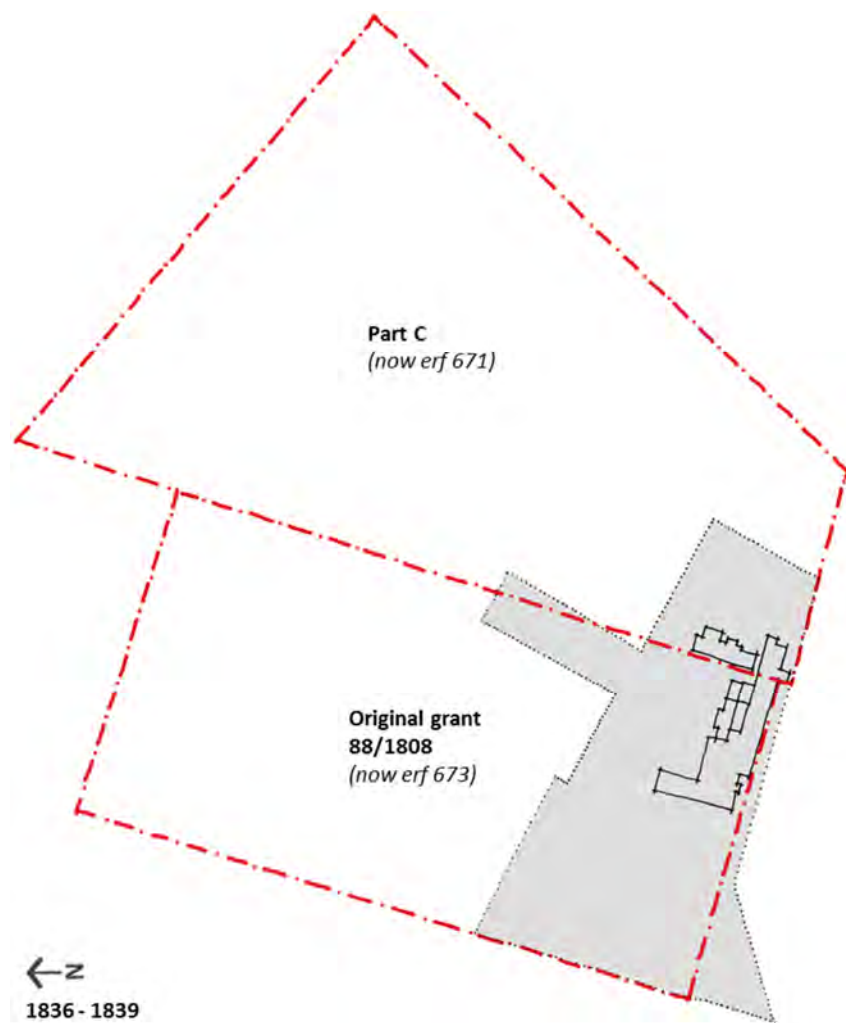
Figure 8: A diagram illustrating the two large parcels of land that Dr. F.L.C. Biccard bought respectively in 1936 from De Necker and in 1939 from the Church (Part C comprising of 2 morgen, 316 square roods and 108 square feet) in relation to the extents of the current Erf 680 (dotted) with the building footprint. (Diagram by J. de Waal.)

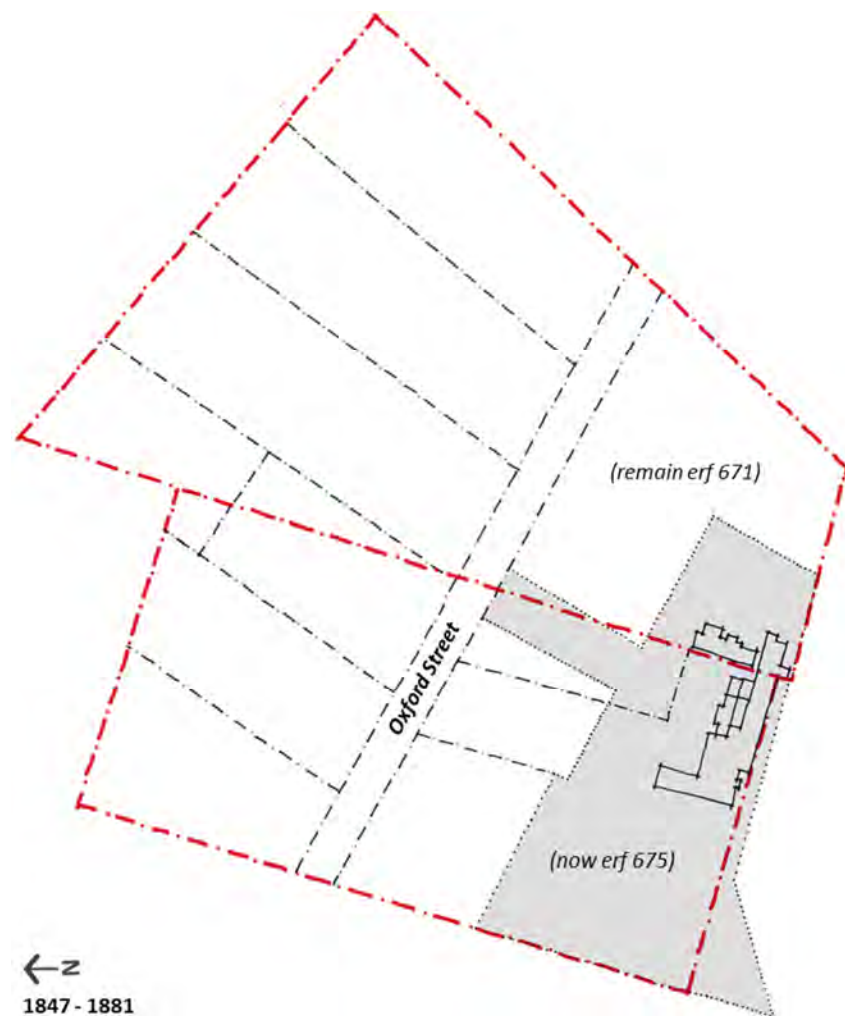
Figure 9: A diagram illustrating the two large parcels of land being subdivided by Pieter van Breda and another who bought it in 1847. It appears as though the building structures remained on one parcel of land. (Diagram by J. de Waal.)

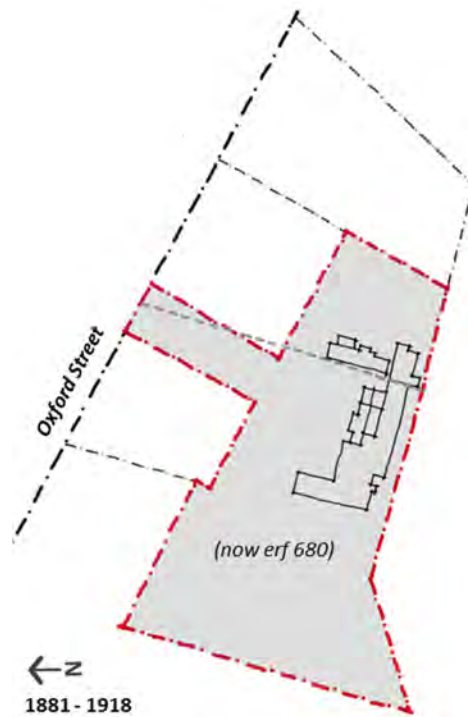
Figure 11: The diagram illustrates the extent of Erf 675 with its subdivisions initiated by the King Brothers who bought the property in 1896 and subdivided it in 1918. The dashed line indicates the location of the original Cape Quitrent granted in 1808. The building footprint represents the building extents recorded on the SG diagram for Erf 675. (Diagram by J. de Waal.)

The King Brothers subdivided the property in 1918 into four erven. (See Figure 11.) Ernest Carl Kuhn purchased the property in its current extents (Erf 680, see Figure 12) from the King Brothers on 30 December 1918.

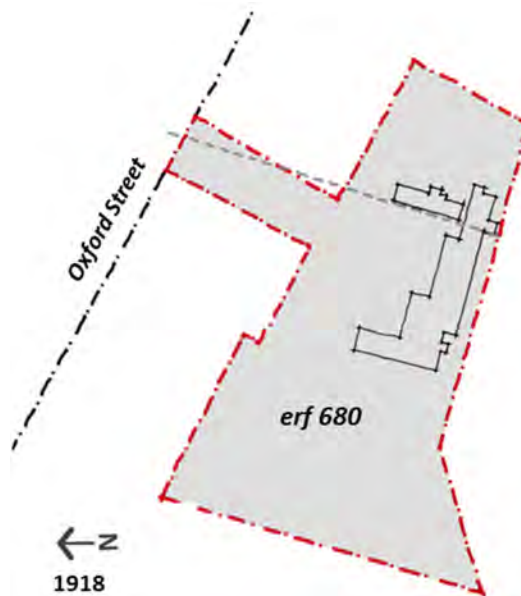
Figure 12: The diagram illustrates the existing extent of Erf 680 with a narrow portion of land connecting to Oxford Street. This short erf boundary is the only erf boundary with direct street access. The dashed line indicates the location of the original Cape Quitrent granted in 1808. The building footprint represents the building extents recorded on the SG diagram for Erf 680. (Diagram by J. de Waal.)

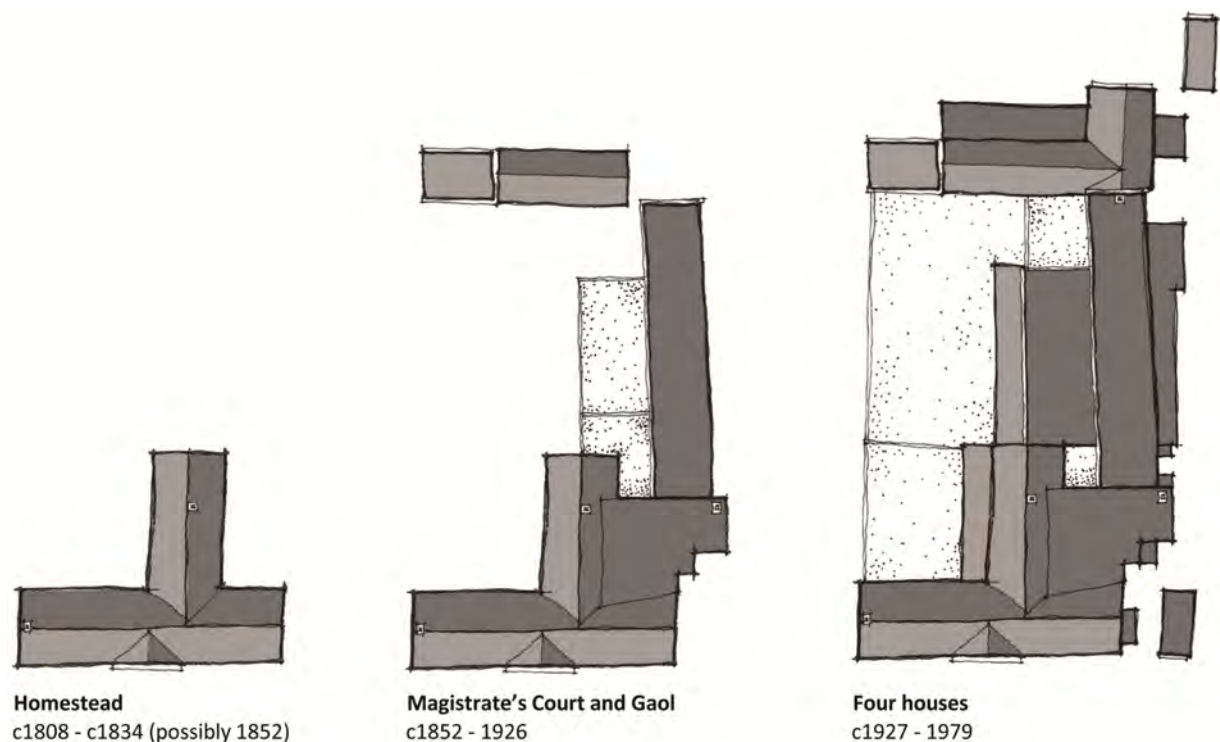
Figure 13: Diagrams indicating the suggested growth of the building complex due to the main uses. Three of the four main uses have been illustrated, namely homestead¹⁸⁵, the magistrate's court and gaol, and the four houses (see Figure 23 for the extents of each house). The current use has not been depicted as most of the changes were internally (see Annexures 8 and 9) and the roofing of the small courtyard. Note that no outbuildings have been included in the homestead sketch as it is uncertain what the extents of the outbuildings were at the time. (Diagrams by J. de Waal.)

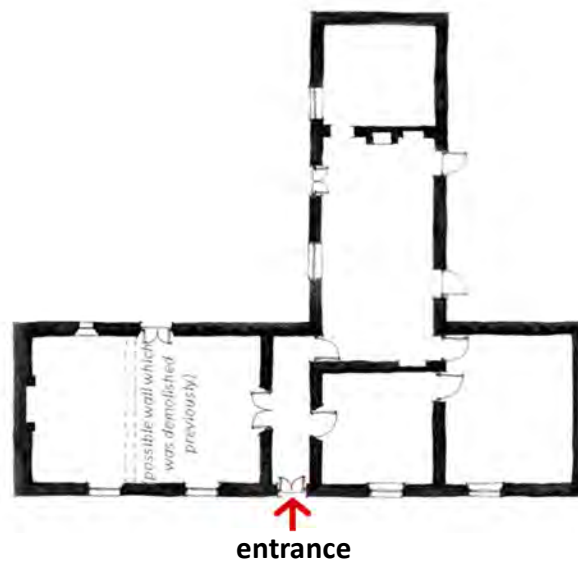
Figure 14: A sketch indicating the possible extents and layout of the T-shaped house (circa 1808 -1834). (This proposed layout could probably have included some internal changes and possible extensions. However, no documentary evidence could be found to substantiate the extents and layout of the original homestead.) The layout appears as though it could be a mirror image of the Kalbaskraal layout plan (see Figure 15). The drawing has been created by using the layouts of Figures 17 and 18, and the current roof configuration. (Drawing by J. de Waal.)

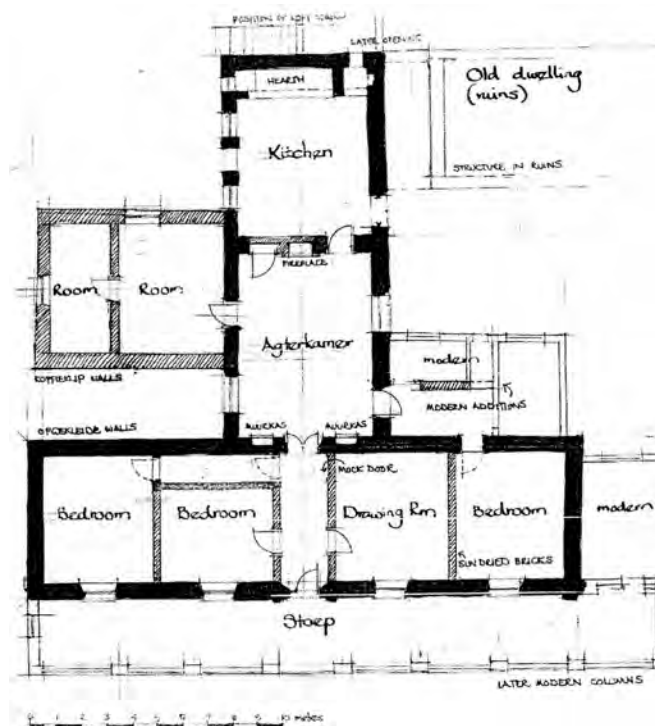
Figure 15: Plan layout of the Kalbaskraal homestead, near Malmesbury. (Source: Van Graan, André. 2003, p. 8.)

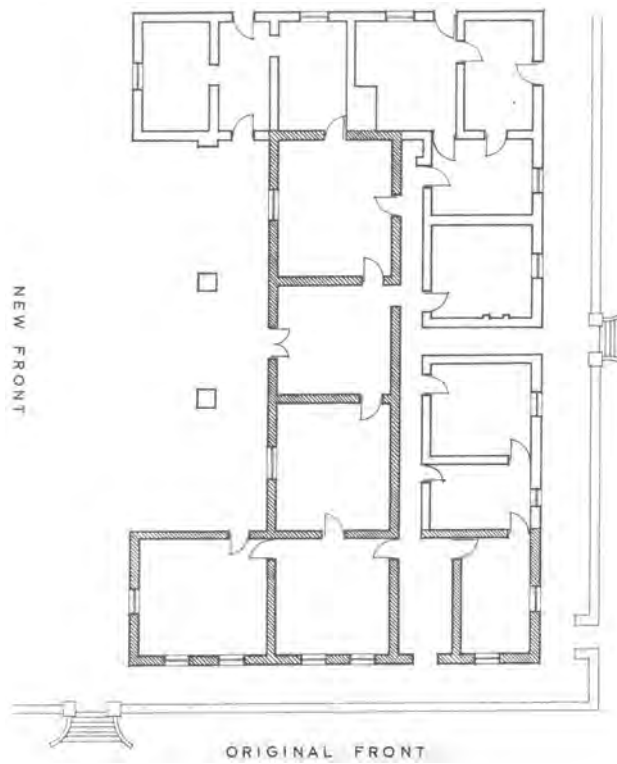
Figure 16: The layout plan of the Drostdy in Swellendam, indicating the original small T-shaped house facing the river, with subsequent additions (probably between 1811 and 1814) to create the larger building to meet the increased needs of the flourishing district. The entrance was moved to the adjacent street of the corner property, facing the road. (Source: Lewcock, Ronald. 1963, pp. 71-72.)

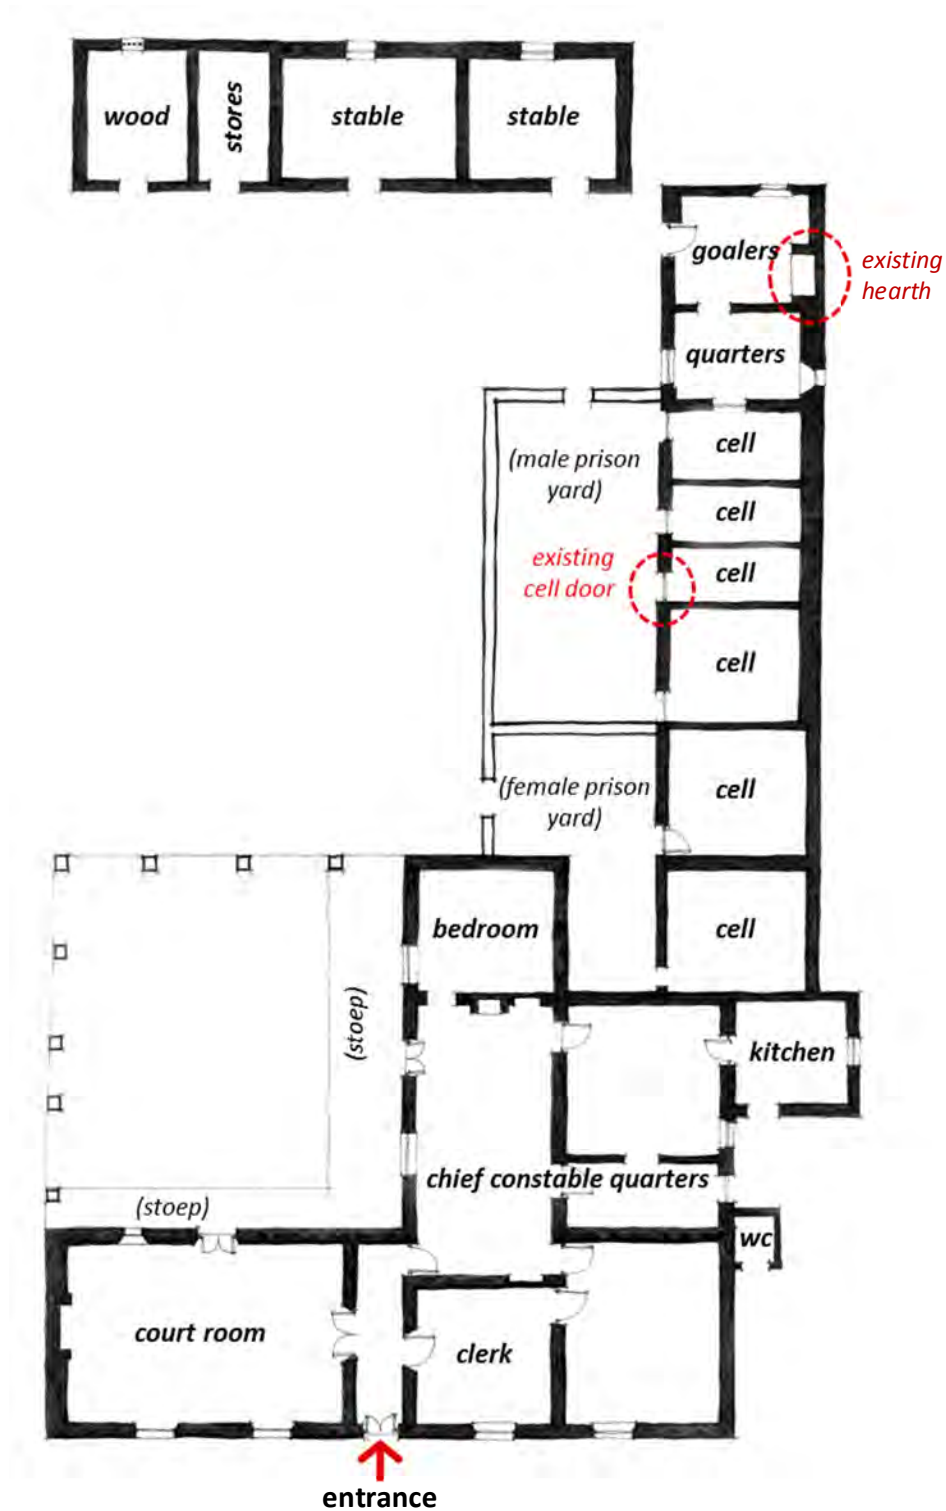
Figure 18: A sketch indicating the layout of the Magistrate's Court and Gaol in 1874. The drawing has been created by using the layouts of Figures 17 and 23. (Drawing by J. de Waal.)

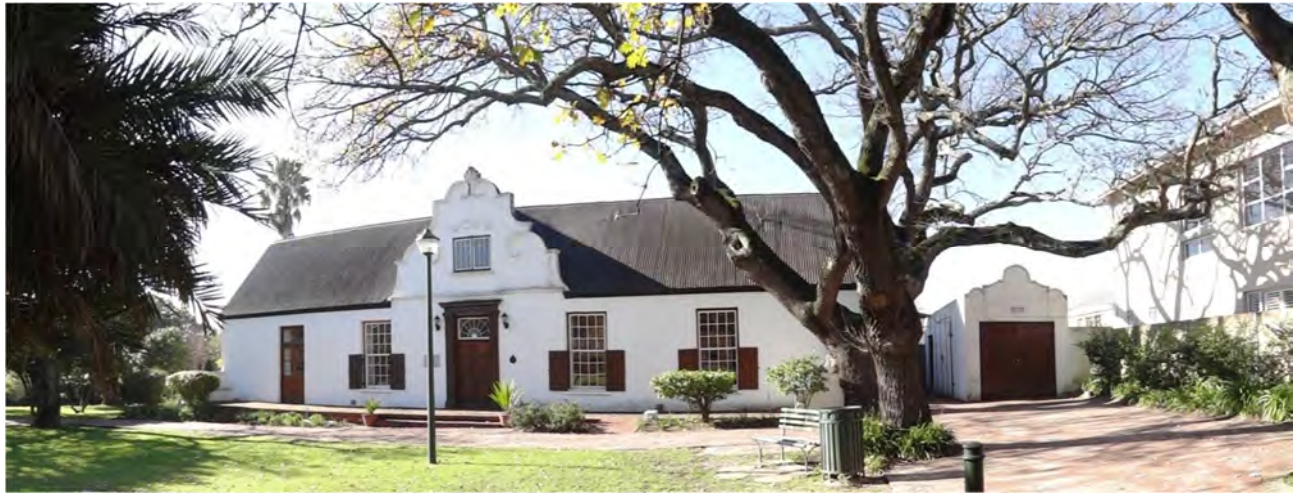
Figure 19: Front (west) elevation of Rust-en-Vrede cultural centre facing Wellington Road. The end gables were clipped to accommodate the new corrugated iron roofing material. Note that no veranda was added to this façade at the time that the other verandas were added, thus retaining the abrupt separation between the house and its setting. (Source: J. de Waal, 29 June 2013.)

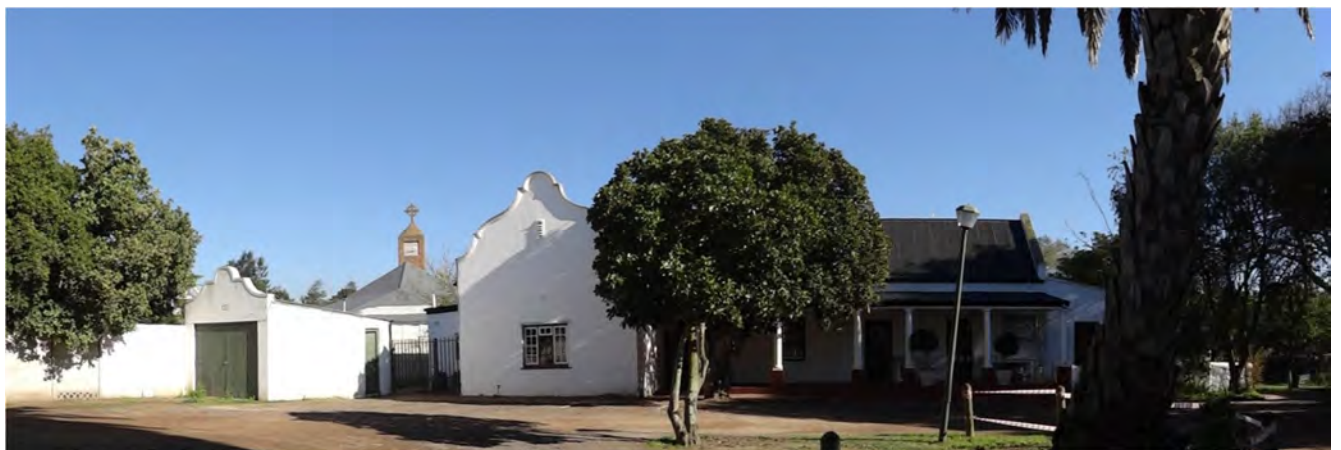
Figure 20: Back (east) elevation of Rust-en-Vrede cultural centre. During the Meneely period, this portion of the building complex was the residence/boarding house, *The Retreat*. Note the new extension with holbol end gable similar to the Welmoed end gable. (Source: J. de Waal, 29 June 2013.)

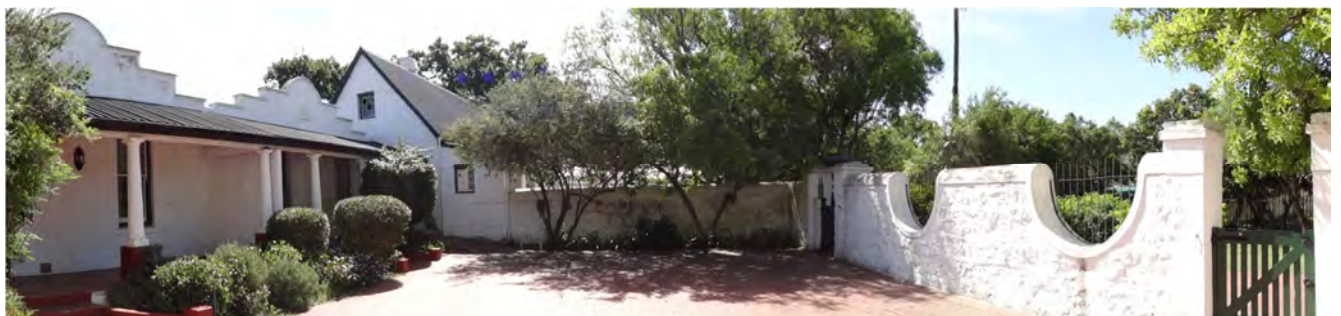
Figure 21: Side (north) elevation of Rust-en-Vrede cultural centre. During the Meneely period, this portion of the building complex represented the two residences *My Vreugde* (left) and *Inglenook* (right), with a shared front courtyard. The existing prison yards were roofed to create the front part of both houses with stepped parapets and verandas. (Source: J. de Waal, 12 December 2013.)

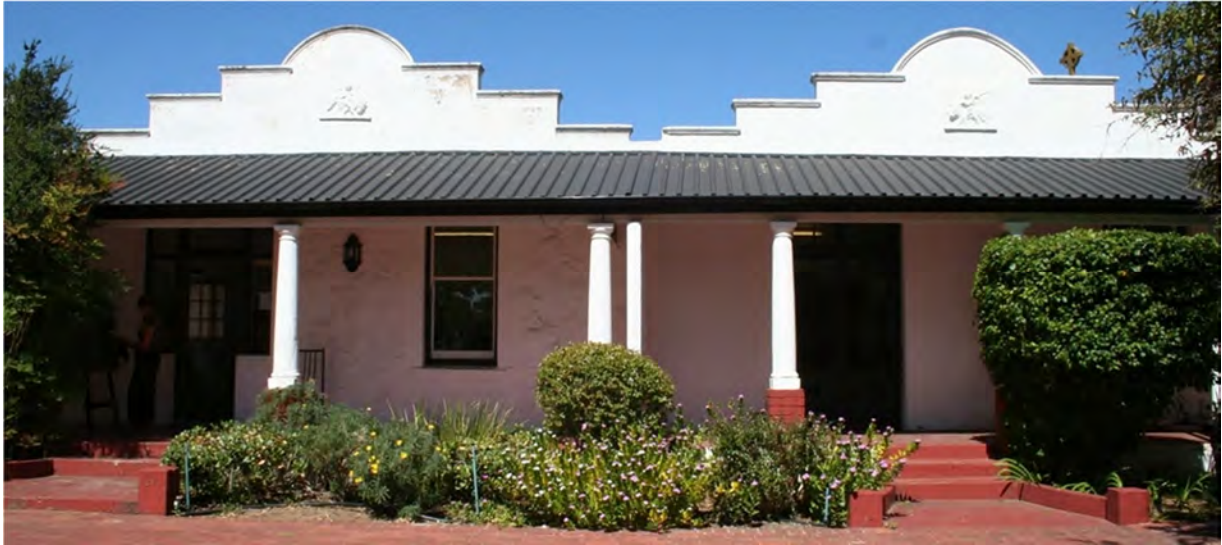
Figure 22: Front elevation of the two residences My Vreugde (left) and Inglenook (right) clearly illustrating the new stepped parapets and verandas. (Source: Hamlin Jansen van Vuuren, March 2014.)

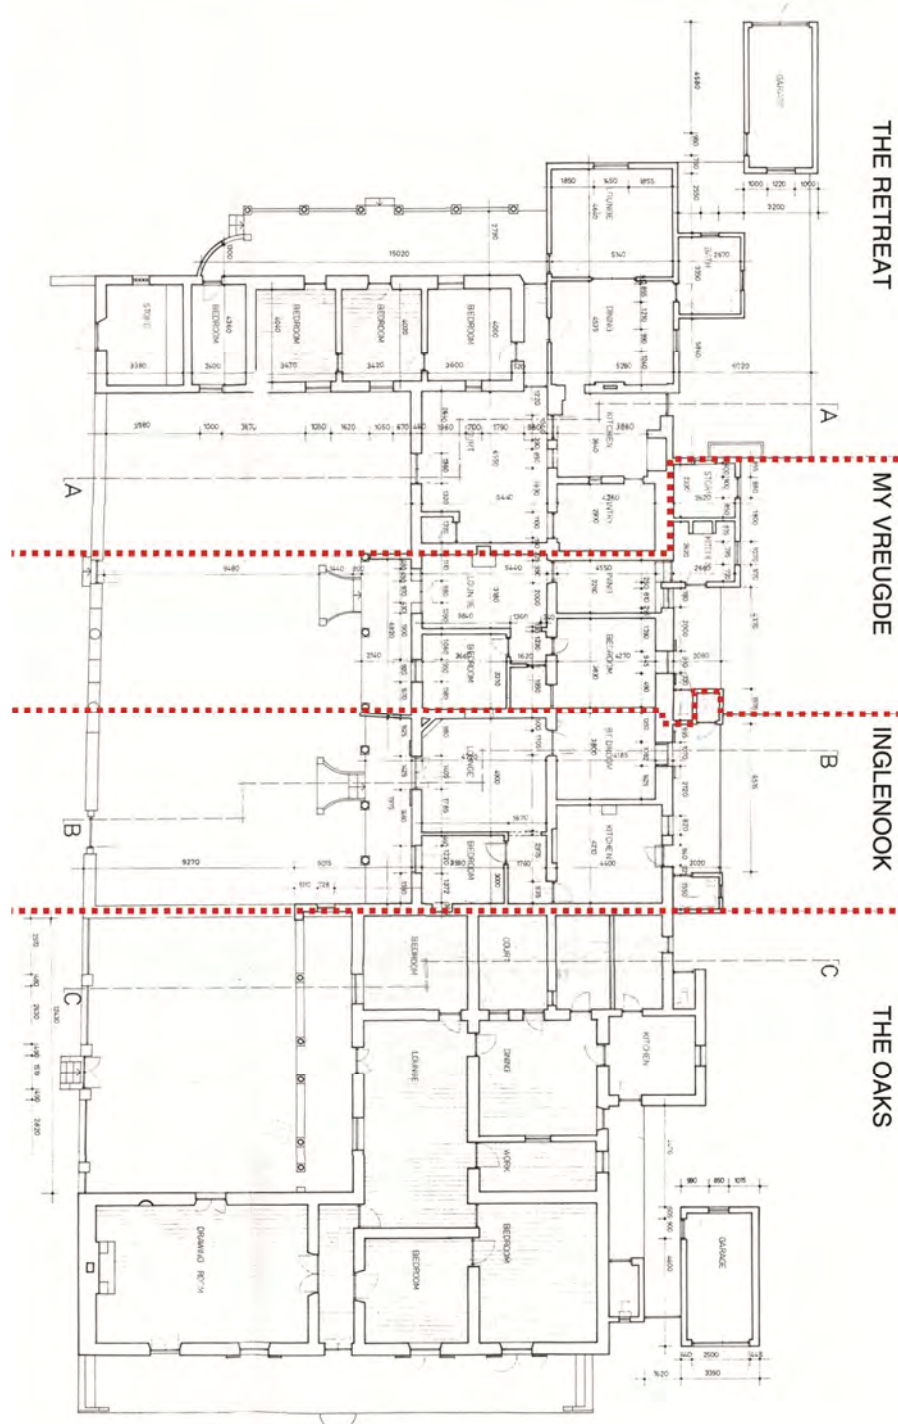
Figure 23: Measured drawing of Rust-en-Vrede (plan and north-east sectional elevation) by Ulrike Kuschke in 1979, prior to the Durbanville Municipality renovations. The plan illustrates the extents of each of the four houses that Mr. Meneely owned (The Retreat, My Vreugde, Inglenook and The Oaks). (Source: CoCT.) Also see Annexure 8 which records the use of each room.

¹⁴ As recorded by the measured drawing (see Figure 23, source: CoCT) and verbal confirmation (source: personal communication with Monica Ross, curator of Rust-en-Vrede Cultural Centre for more than 10 years, on 22 January 2014).

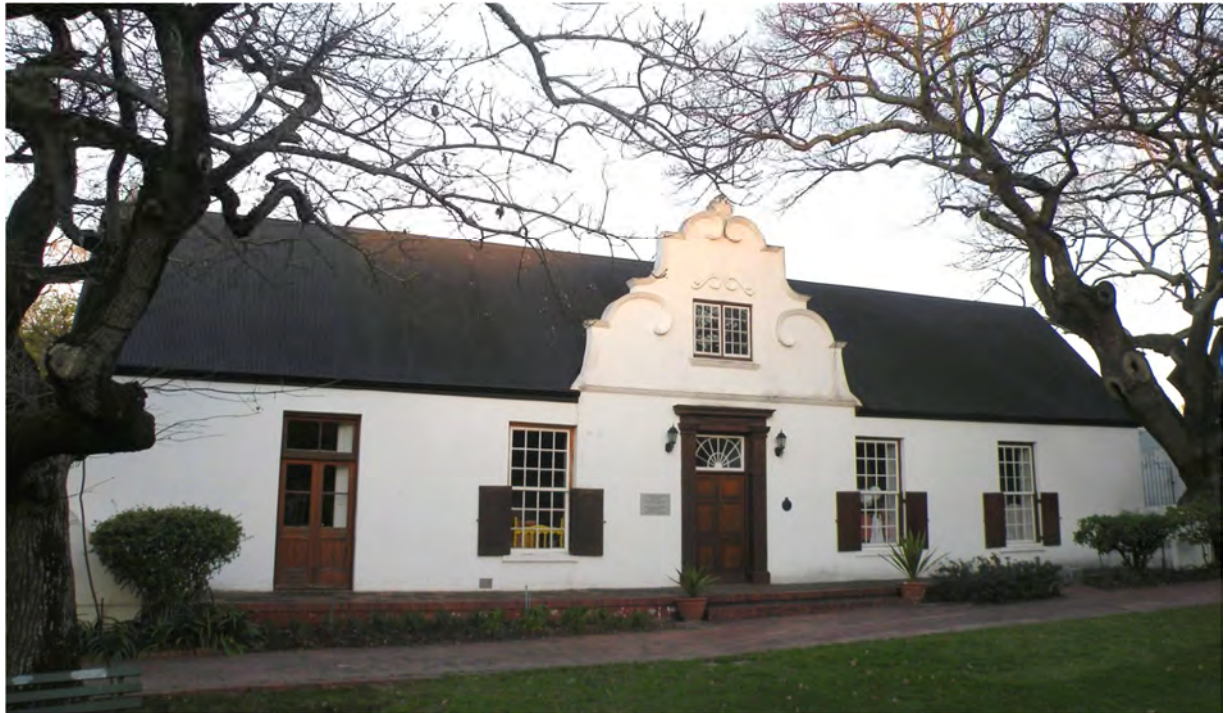
Figure 24: Rust-en-Vrede (homestead) with centre gable. During the Meneely period this portion of the building complex was the residence The Oaks. (Source: Hamlin Jansen van Vuuren, July 2013.)

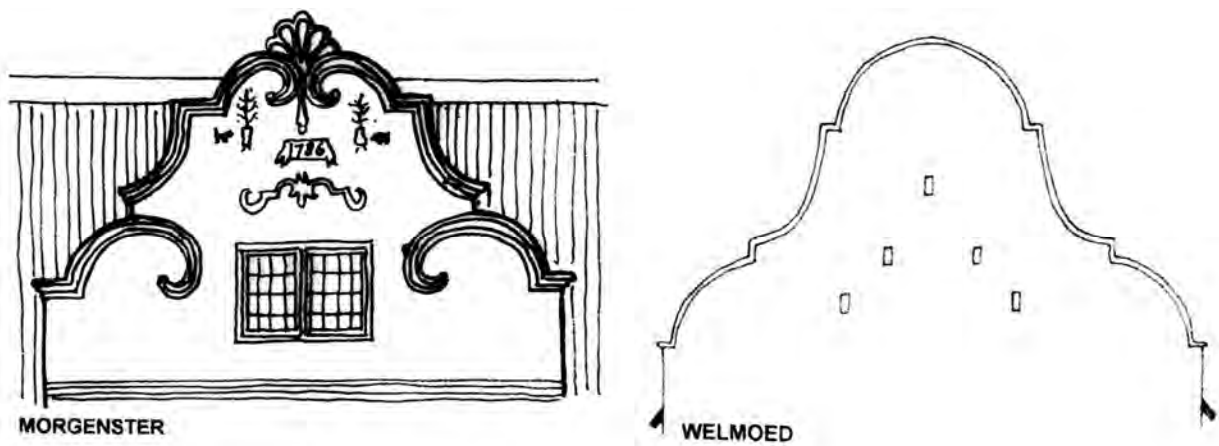
Figure 25: Sketches of the two holbol gables that were probably used as examples on which the two existing main gables at Rust-en-Vrede were constructed, namely the front gable of the farm Morgenster off Lourensford Road in Somerset West and the end gable of Welmoed's outbuildings at Moddergat Road (near Lynedoch Station in the Somerset West area).²¹⁴ (Source: Fransen, Hans. 2004, pp. 3, 11.)

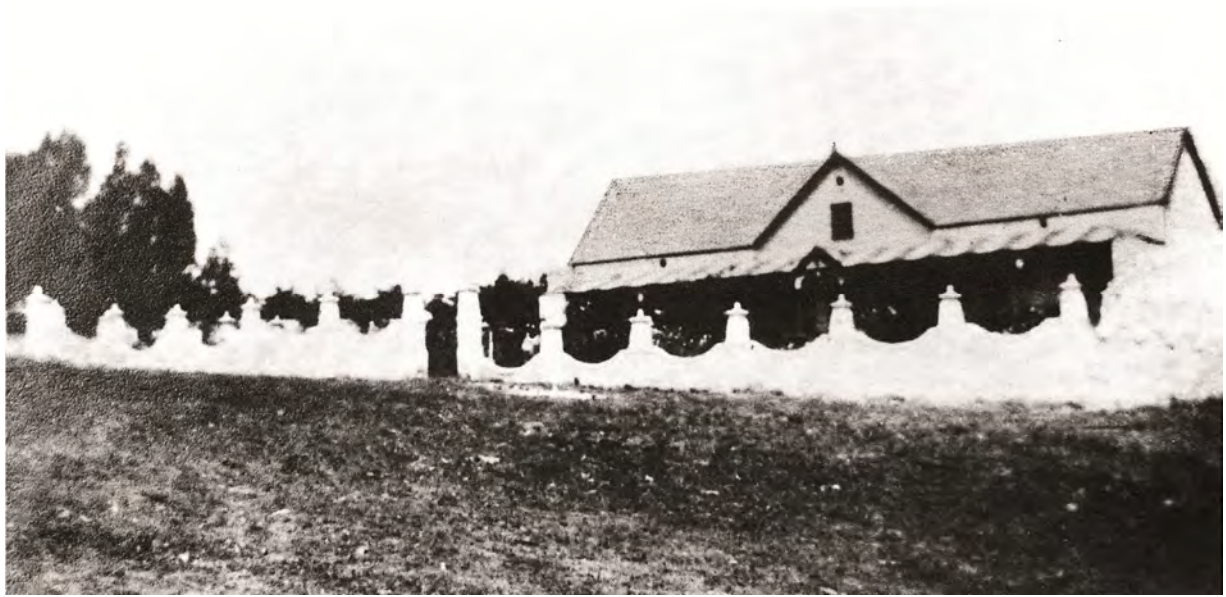
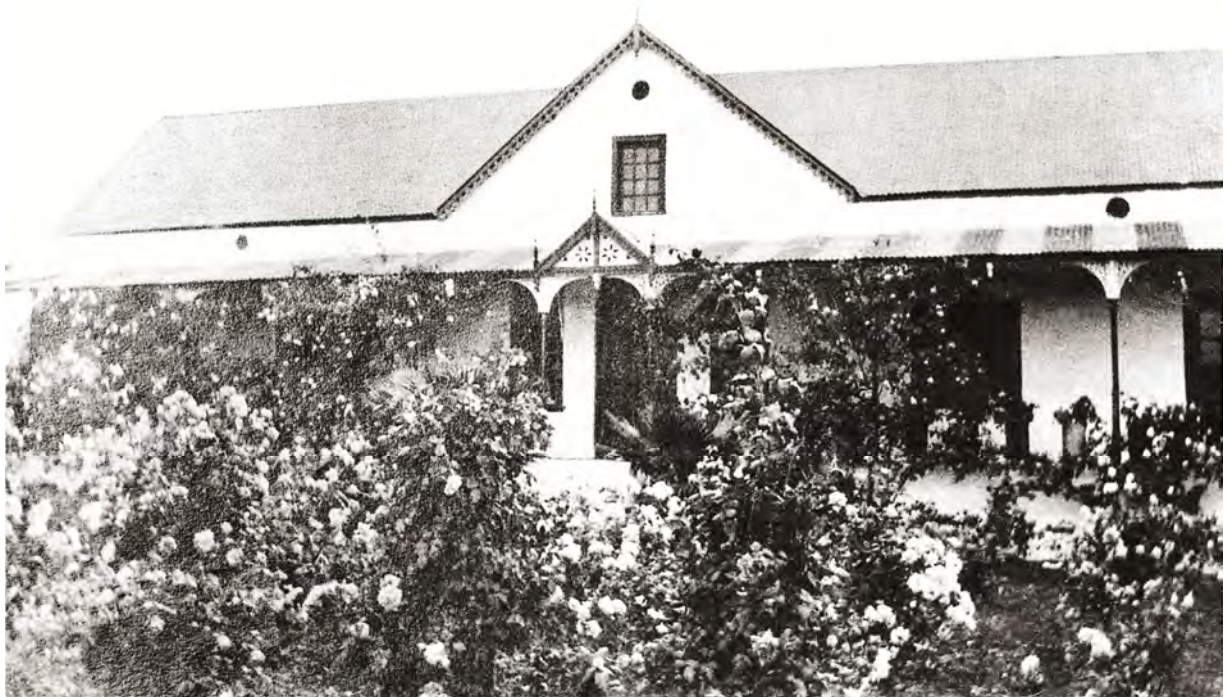
Figure 27: Both photographs, supplied by the owner, Matthys (Tienie) Louw, were taken in the late 1800s as recorded by Pretorius. According to Pretorius the original rectangular cottage was changed into a T-shaped house, which was enlarged to an H-plan layout with front and end gables in the 19th century. The images clearly indicate a simple centre gable with corrugated iron roof sheeting (replacing the thatch roof), clipped gables and a verandah. (Source: Pretorius, 1997, p. 22.)
